PASSAIC RIVER BASIN

IRISH BROOK DAM

**PHASE I INSPECTION REPORT
NATIONAL DAM SAFETY PROGRAM**

NJ 00204

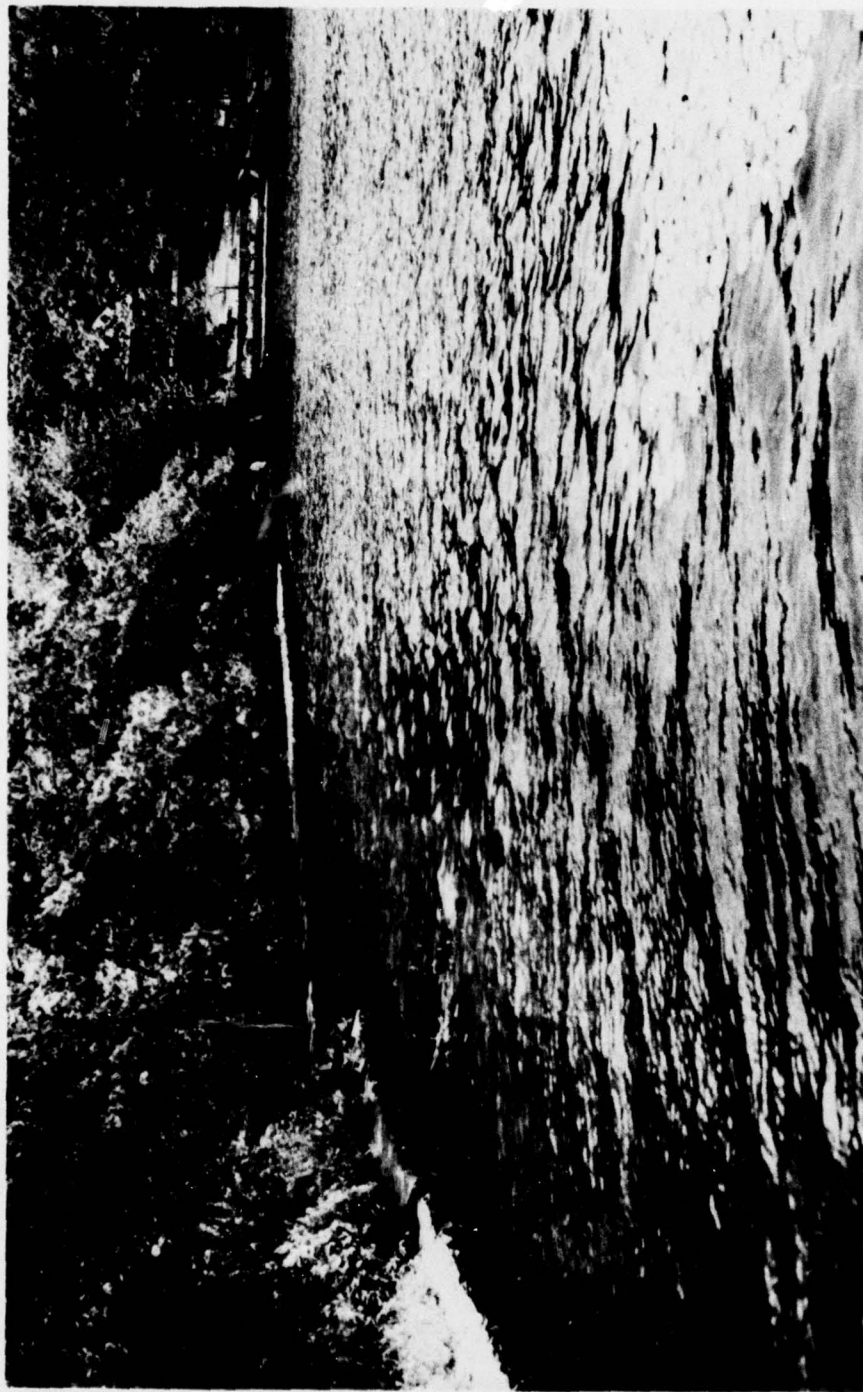
View of dam, spillway and both abutments from left shoreline.

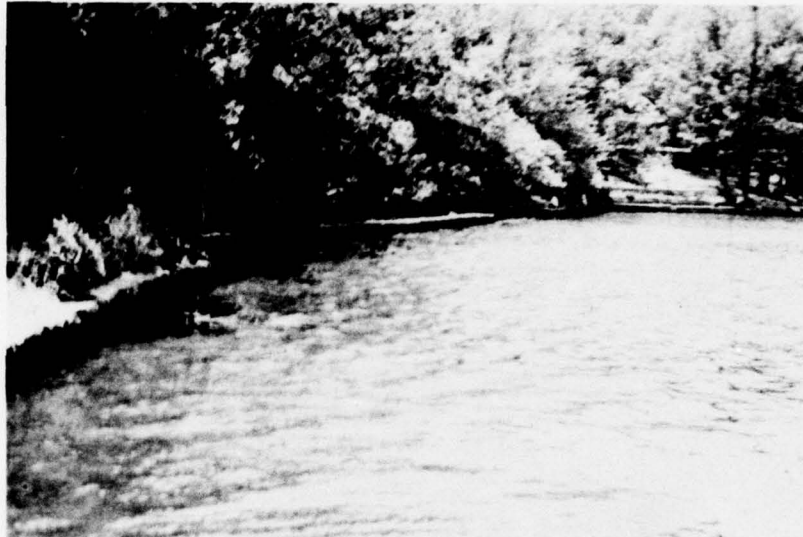
Photo 1 - View of dam, spillway and both abutments from left shoreline.

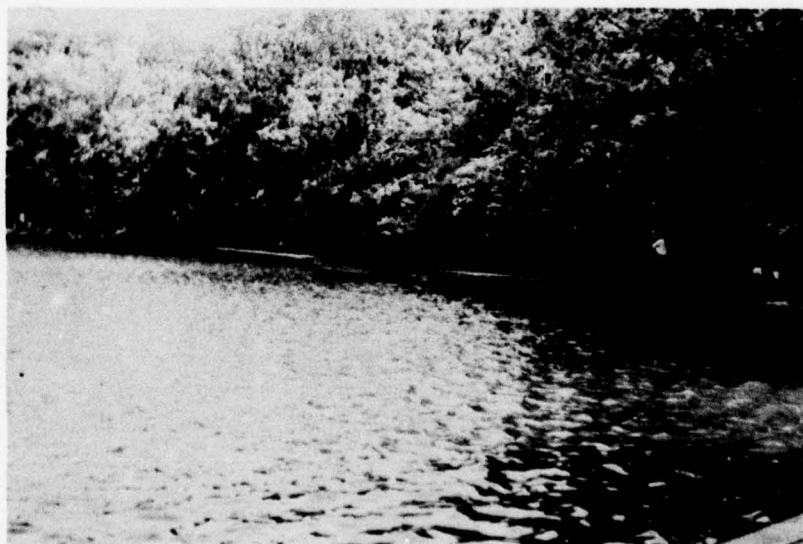
Photo 2 - View of dam and notch spillway from right shoreline.

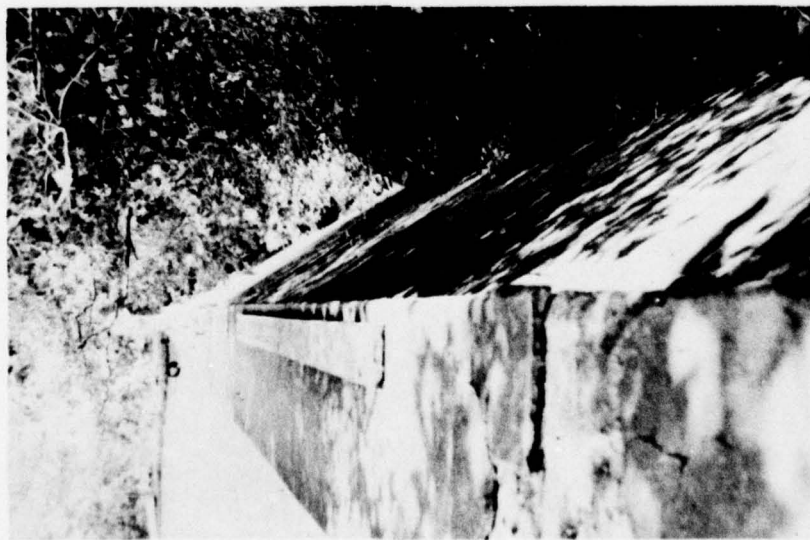
Photo 3 - Crest and downstream face of dam.

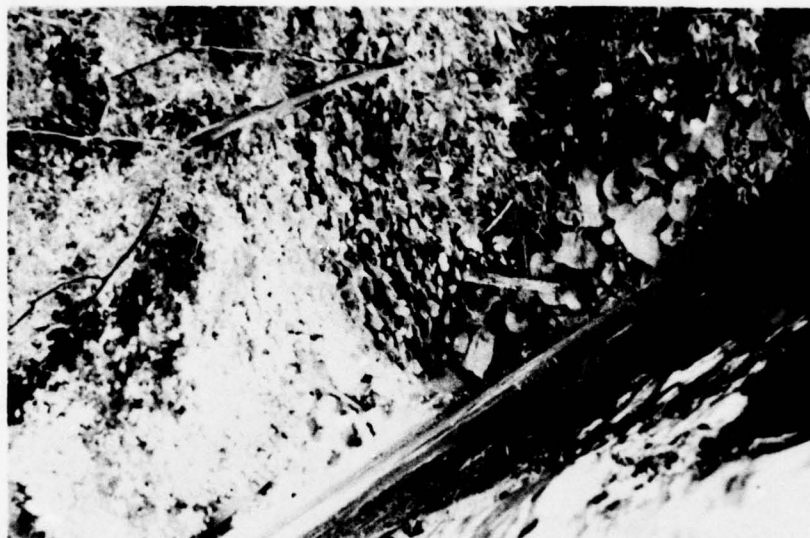
Photo 6 - Looking at downstream toe and area from right side of spillway.

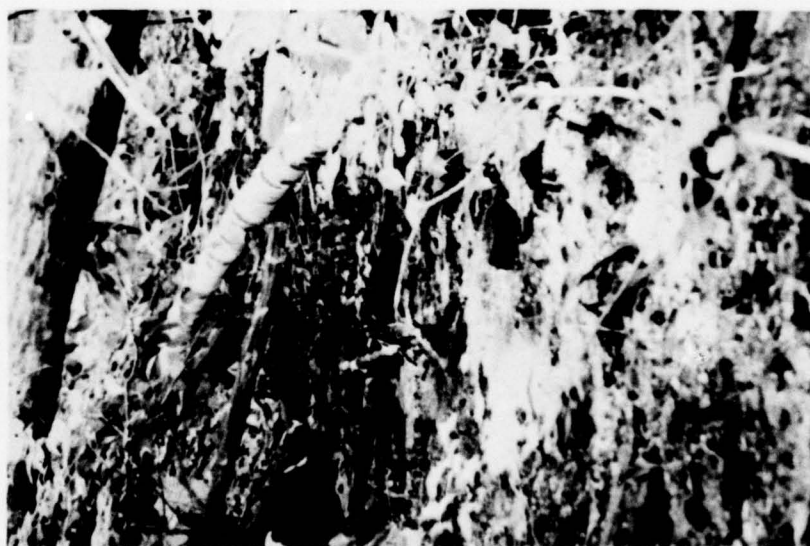
Some horizontal construction joints show evidence of past leakage with the presence of leaching deposits, however, virtually all joints were dry at the time of the inspection. A seep was observed approximately 20 feet downstream of the dam near the right abutment. Estimated seepage was about 2 g.p.m. and appeared to be free of fine soil grains.

Photo 5 - View of seepage right side of dam.

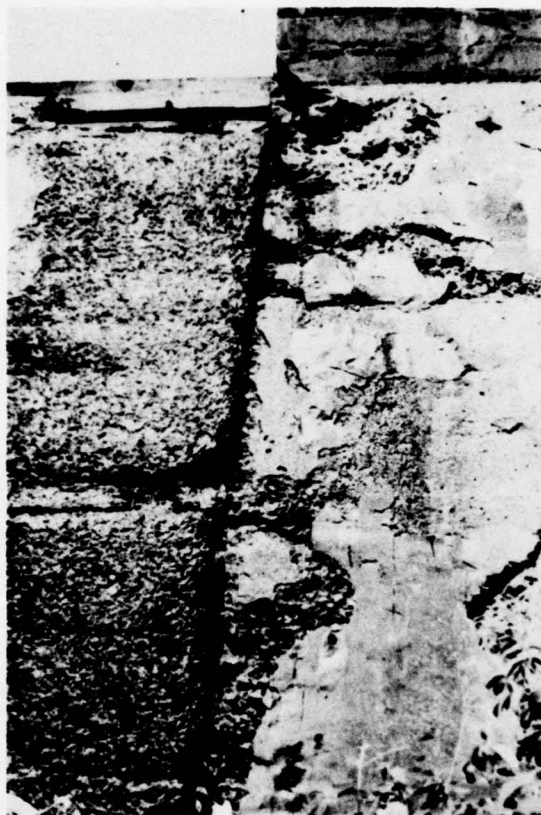
The downstream surface is moderately spalled. The surface has been patched numerous times to keep it in good condition. A vertical construction joint was observed on the right side of the spillway. While the joint had been patched with mortar, it continues to seep and a build-up of leaching deposits was observed.

Photo 7 - Construction joint and
spalling left side of
notch spillway.

Areas of deteriorated, spalled or seriously cracked concrete should be repaired annually to prevent progressive damage.

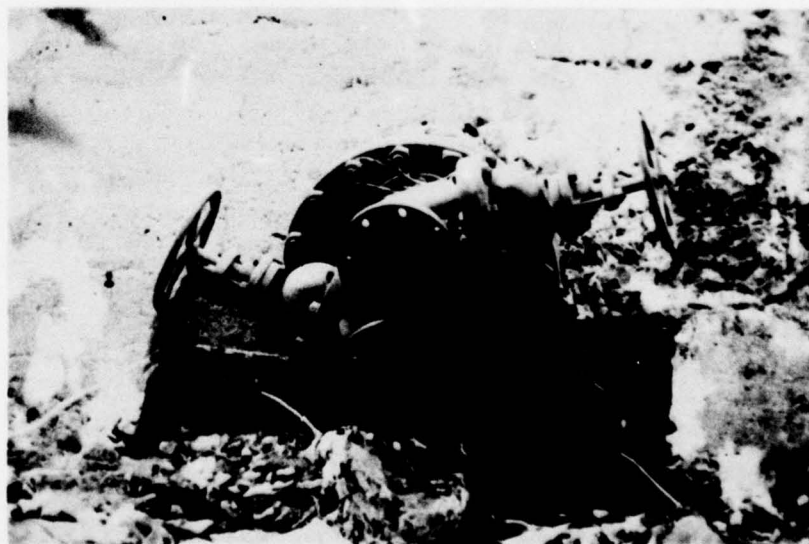
An 18-inch diameter cast iron pipe, fitted with a flange plate and two 6-inch gate valves, is located 22.5 feet left of the spillway, 15 feet below the crest. The pipe and valves have been plugged and are no longer operable. The sluice gate located in Post Brook Dam is the only facility for draining the lake. Operation is every 5 to 7 years as previously noted and maintenance is as needed.

Photo 8 - View of two 6-inch valves installed on flange
plate on plugged 18-inch cast iron pipe.

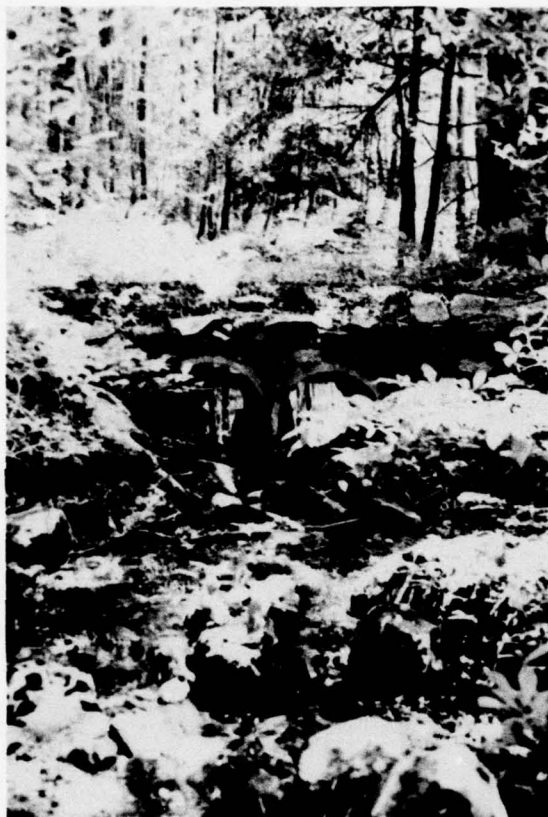
Photo 9 - Two culverts under private road downstream of dam.

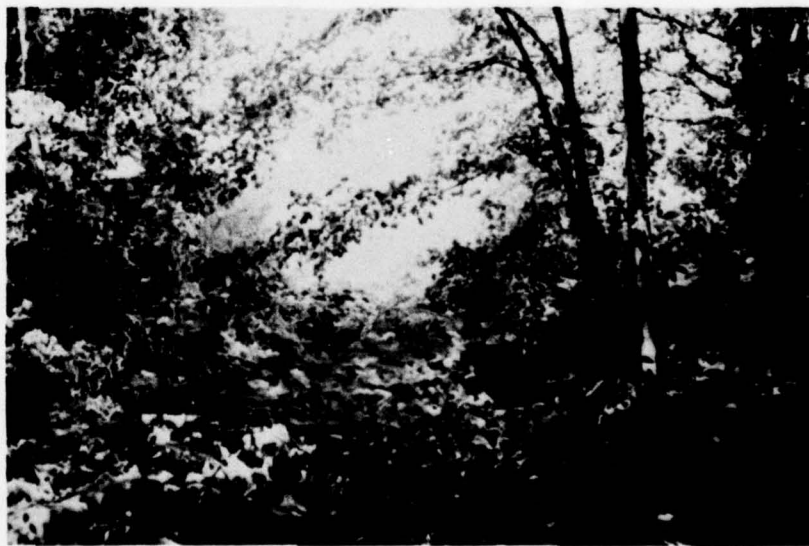
Photo 10 - Discharge channel looking upstream from culverts.

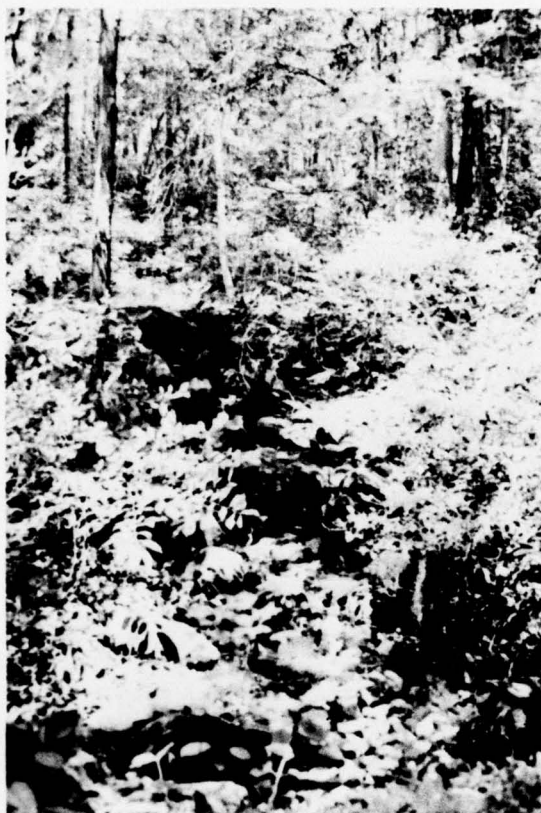
Photo 11 - View of discharge
channel looking toward
the dam.

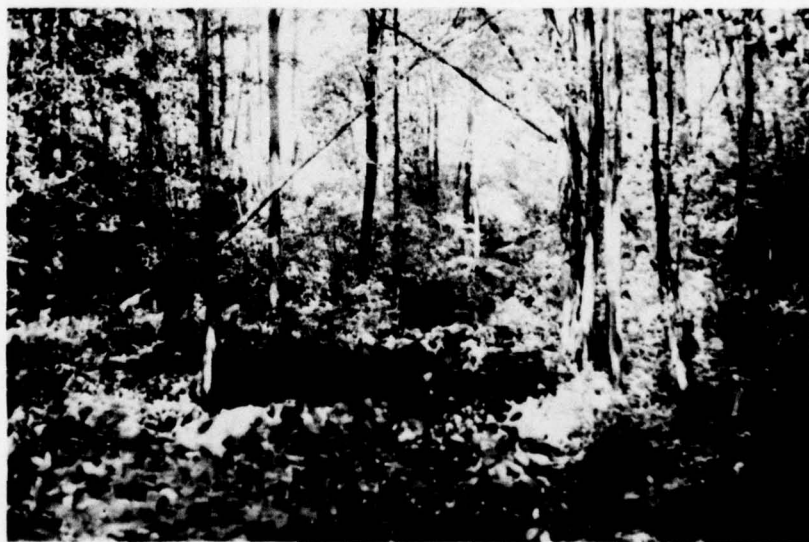
Photo 12 - Discharge channel looking toward dam.

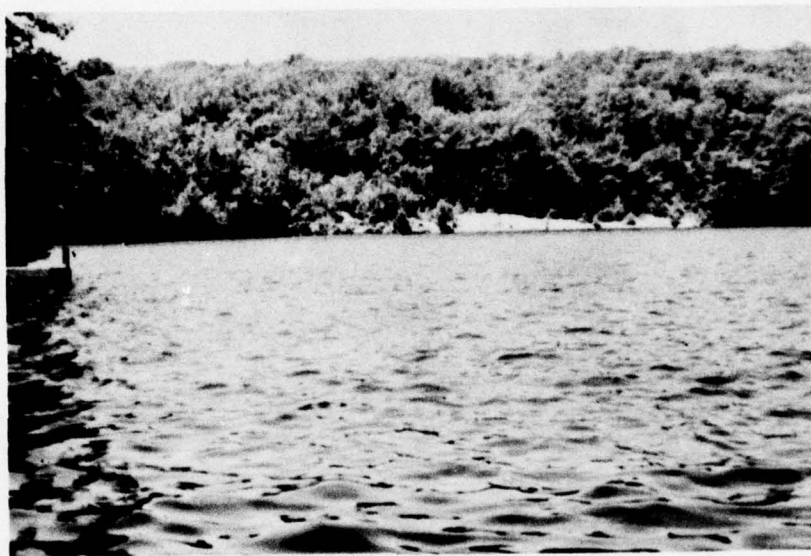
Photo 13 - Lake Iosco and right shoreline showing rock outcrop.
